## SPACECRAFT MATERIALS STUDIES ON THE AEROSPACE CORPORATION TRAY ON EOIM-III

Wayne K. Stuckey, Carol S. Hemminger, Gary L. Steckel, Malina M. Hills, and Michael R. Hilton Mechanics and Materials Technology Center

The Aerospace Corporation
2350 East El Segundo Blvd.
El Segundo, CA 90245

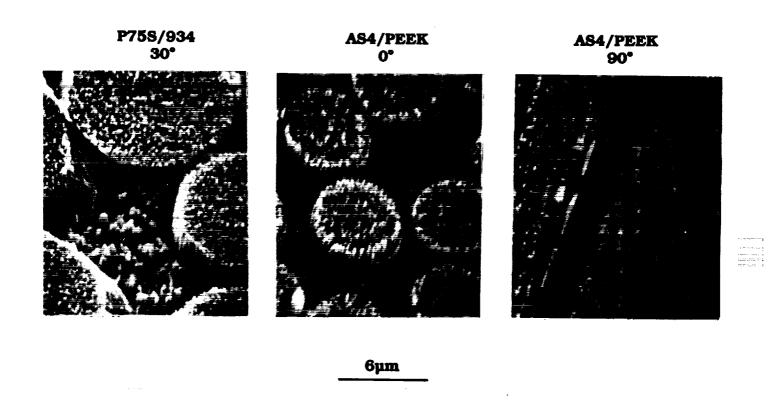
Several observations were made from SEMs of the erosion surfaces as shown in Fig. 2. The 934 epoxy and PEEK thermoplastic matrix erosion rates were significantly higher than those for the P75S and AS4 graphite fiber, respectively. The erosion morphologies were similar for the two polymer matrices. Similar erosion features were observed on the ends of the AS4 fibers, perpendicular to the fiber axis, and on the sides of the fibers, parallel to the fiber axis. Although not shown in Fig. 2, the P75S fiber also showed no orientation dependence for the erosion morphology. Finally, the P75S fiber eroded with a more uniform, finer structure than the AS4 fiber. This is contrary to the result anticipated from LDEF observations. Unfortunately, this experiment did not enable interpretation of LDEF atomic-oxygen erosion morphologies.

Figure 2. Scanning electron micrographs of atomic-oxygen erosion features for graphite-fiber-reinforced polymer matrix composites flown on EOIM-III. The fiber axis orientation relative to the atomic-oxygen velocity vector is shown for each micrograph.
